Power Line Communication and EMI

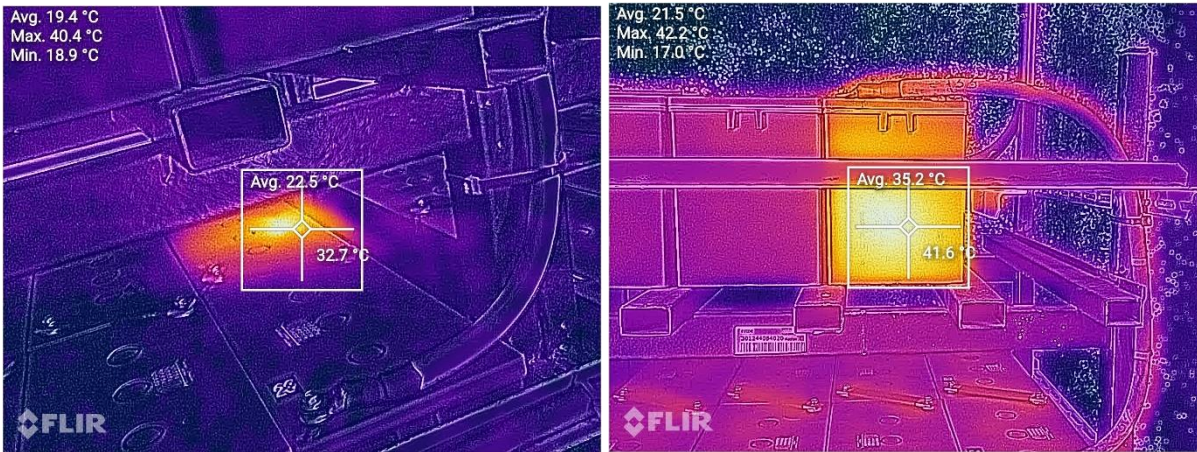
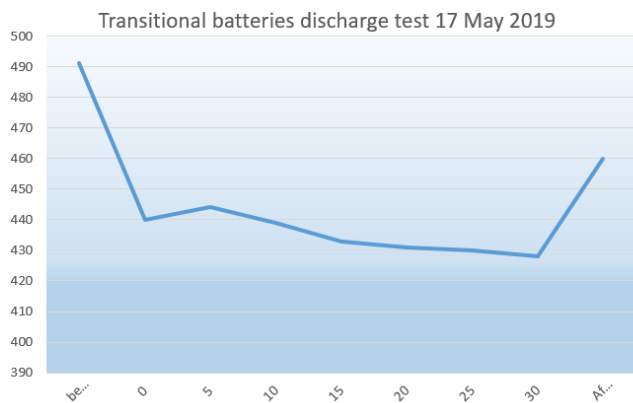
Time (min)	Voltage (Vdc)	Current(Idc)	UPS Load(kW)	Voltage(Vac)	Current(Sac)
before (trickle)	491	0	83,6	223	223
0	440	33	83,6	223	223
5	444	33	83,6	223	223
10	439	33	83,6	223	223
15	433	33	83,6	223	223
20	431	33	83,6	223	223
25	430	33	83,6	223	223
30	428	34	83,6	223	223
After(charge)	460	7	83,6	223	223

Room temperature 15 degC
 Battery temperature 14 degC

Batteries in UPS's specialy transitional UPS (emergency lighting, critical consumers) should be regularly tested by full load discharge test. Apart from total Voltage drop curve check and each battery voltage check , it is recommended to do thermal survey of battery connections (lose connection check) and batteries housing for trace of cells overheating.

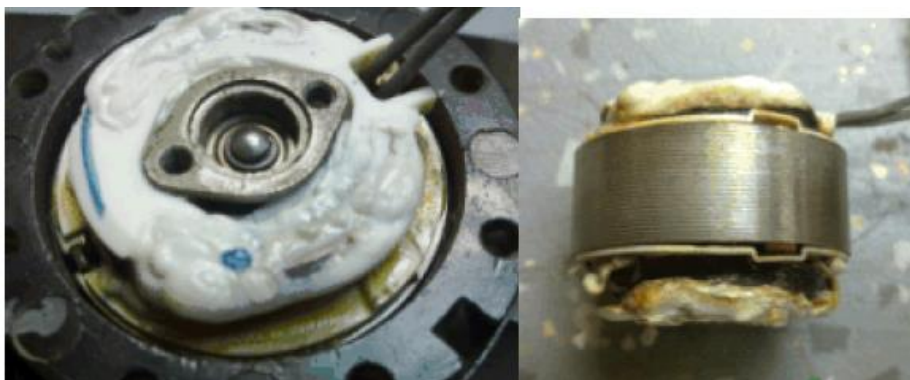
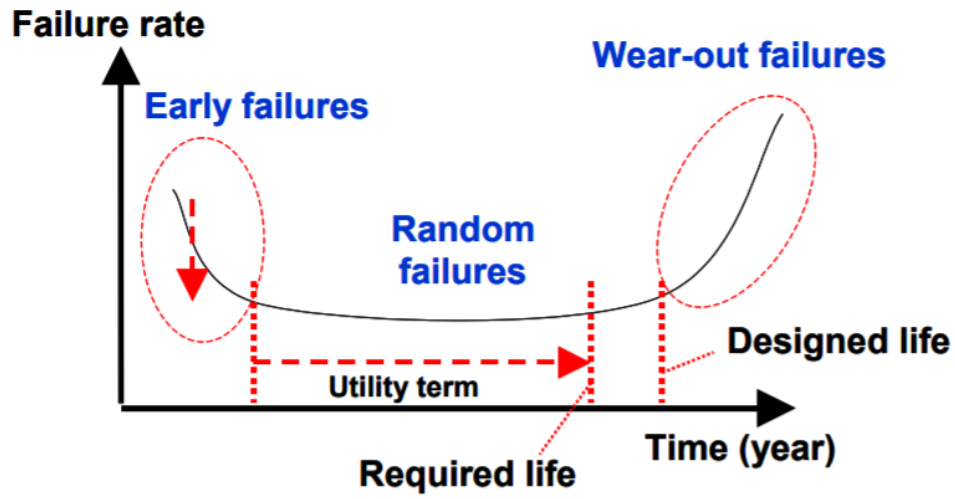
IGBT can latch up and giving temporal DC on output, partly burning itself(fans) and consumers..

Only reliable UPS inverter output protection is isolation transformer and preventive maintenance according to producer recommendations (Capacitors, batteries, fans replacement, control and power modules replacement). UPS lifetime for critical applications should be 10 years. Cost of further maintenance and questionable reliability, overshoots new UPS purchase/installation.

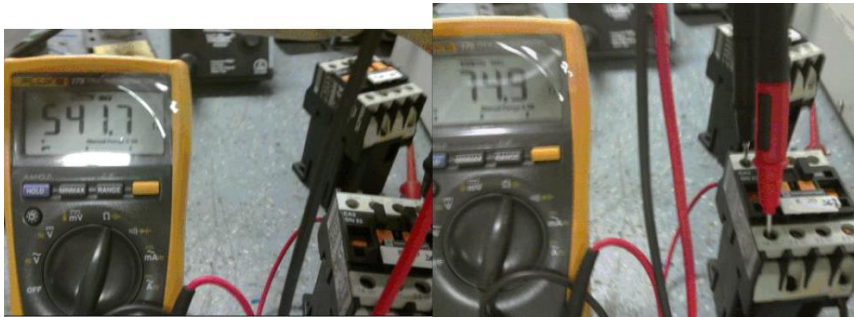
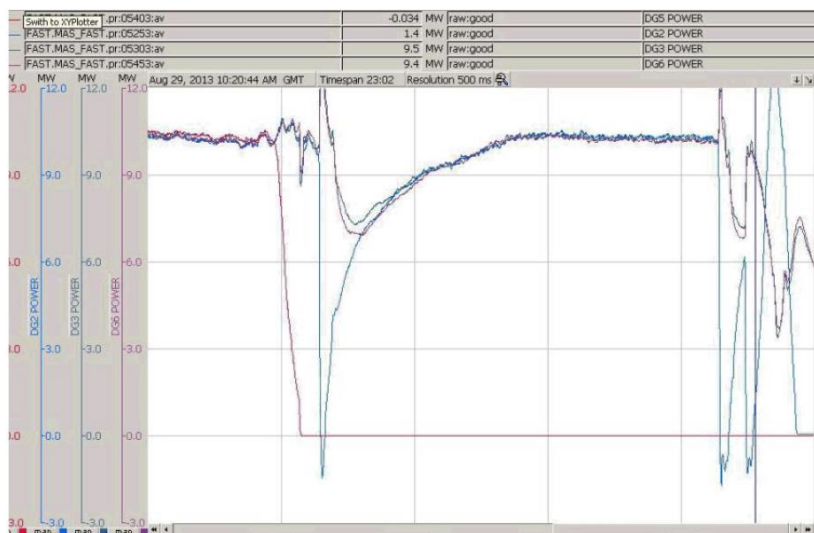
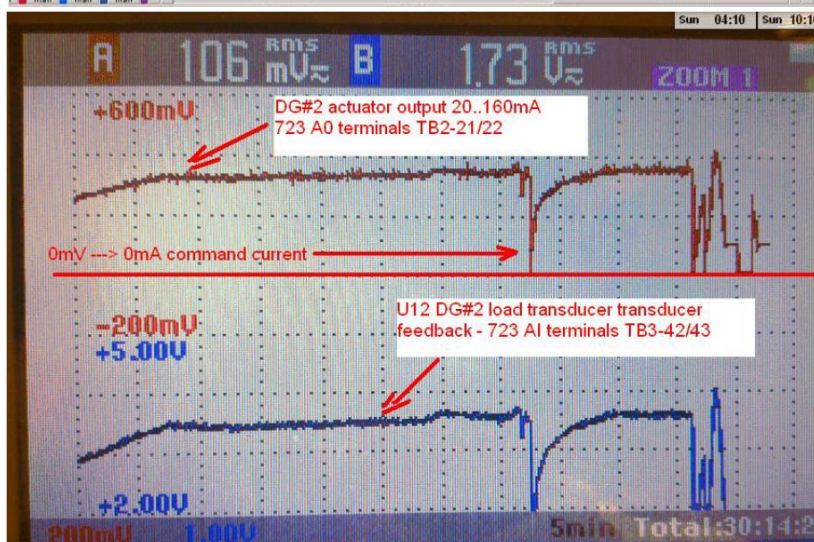
Generators main breakers failures (mechanical issues, poles high resistance leading to breaker overheating, loose connections in breaker feedback multiswitch, SF4 gase leakadge)

Synchronization issues due to mechanical/electrical prime moover speed control faults, fuel injection problems, frequency transducers aging/offsets

Gensets deloading: Aging of contactor coils in DG control pannel causing main breaker open feedback to Woodward723 and immediate command for generator deloading

Stable PMS operation could be affected by aging process of its components. PMS should not be taken for granted by crew during manouverings and there should always be enough 'reliable' gensets connected. Minimum 3 gensets should be connected in manouvering condition. Manouverings on margin with 2 gensets should be prohibited.

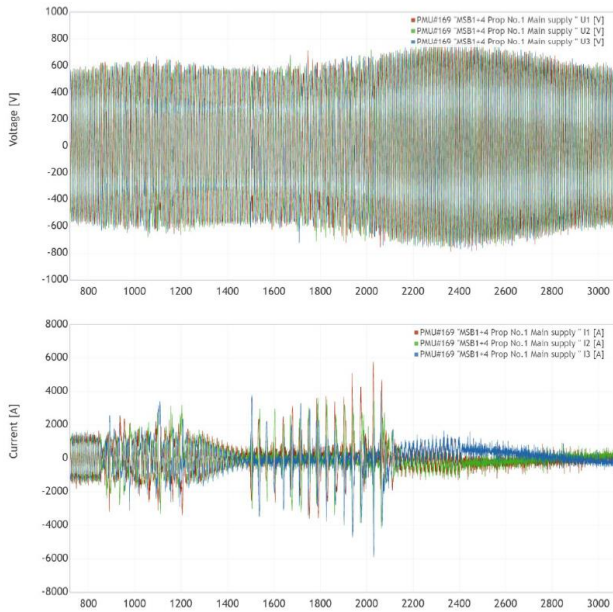
Regenerative power causing drive DC link overvoltage trips and gensets reverse power trips / absence of breaking resistor.

Tripping drive

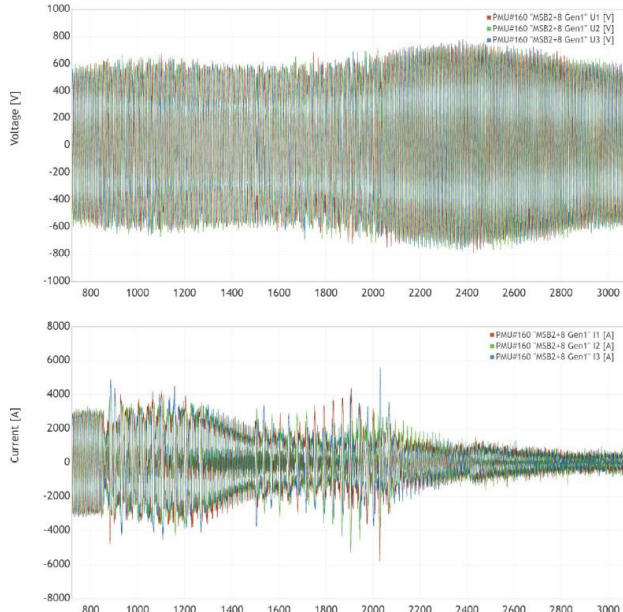
Tripping genset

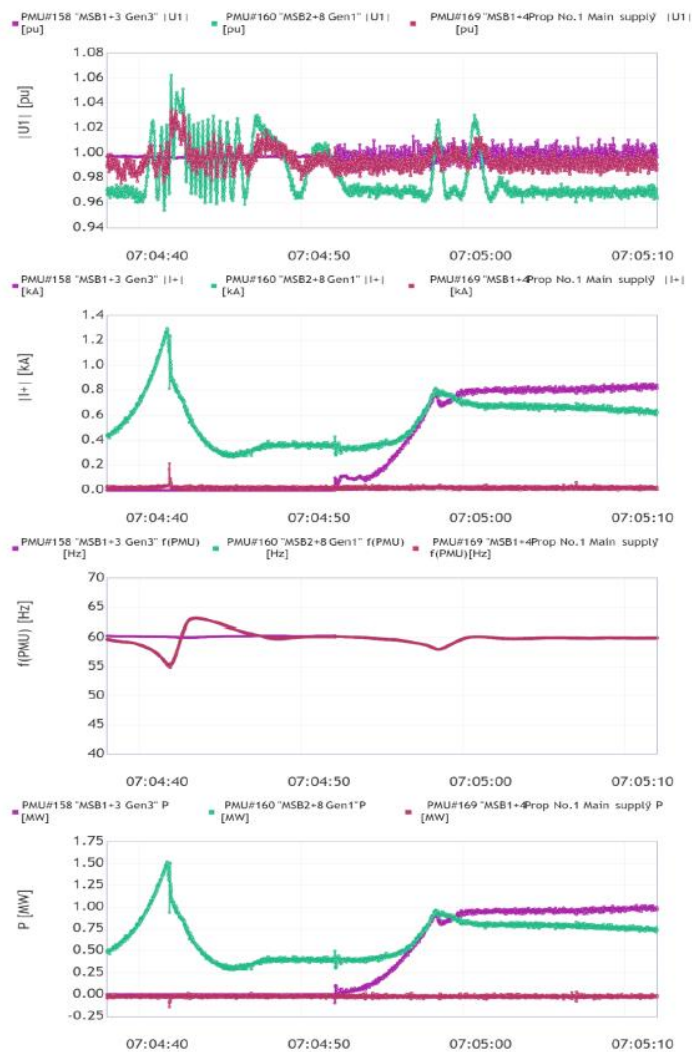
PMS stabilisation after starting another genset

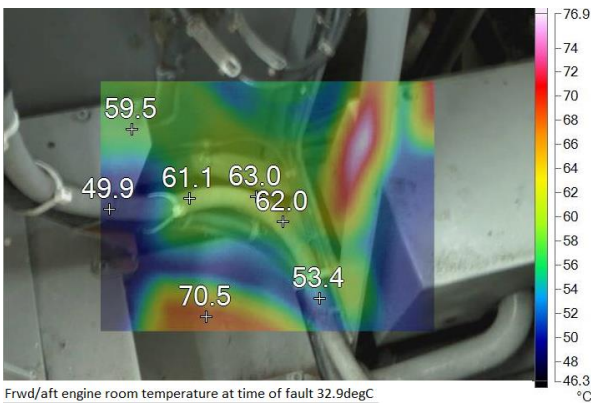
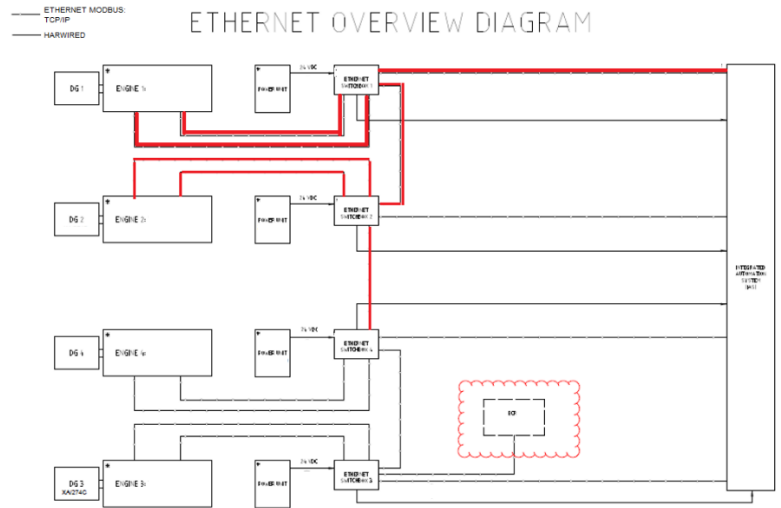
It is of very high importance to use Marine approved cables especially for critical applications and areas. Below is case when Integrated Automation System lost communication with DG automation (TCP/IP Modbus). After rebooting engine controller, communication was restored. Earlier another engine communication alarm (engine automation to IAS) was received for short time as well. After investigation found that CAT5e cable used (Belden 1633ENH CAT 5E F/UTP LSNH) is not Marine type (not oil/chemical resistant as well), with max allowed working temperature 60 degC . Affected communication cables ambient temperature near engine found to be more then 60 deg C (meassured with thermal camera Fluke Ti450).

Due to unshielded pairs of cable and temperature limit of installed CAT 5e, high temp cause imbalance between the cable pairs, degrade electrical performance and increase susceptibility to ambient EMI/RFI. As consequence increased data transmission errors caused stop of communication between engine automation and ship automation system (IAS). The rated operating temperature of the insulating material shall be at least 10 °C higher than the maximum ambient temperature likely to exist, or to be produced, in the space where the cable is installed. (**Ref. IEC 61892-4, sec. 4.10**).

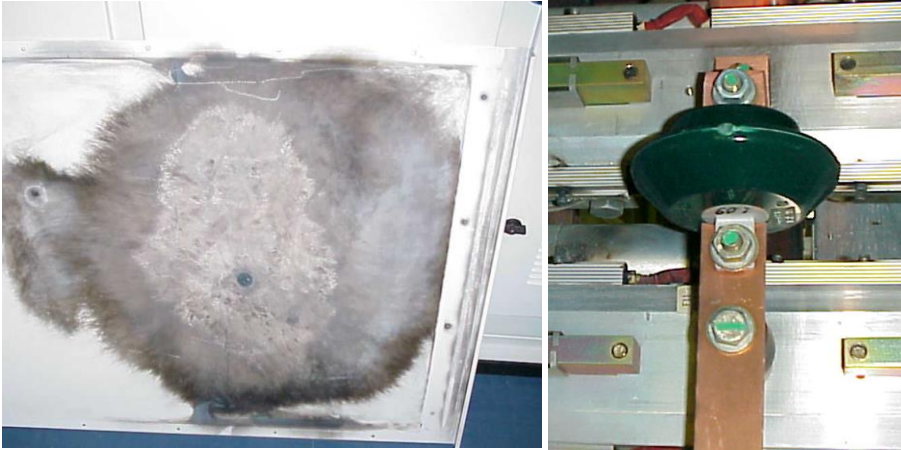
Explosion of Varistor

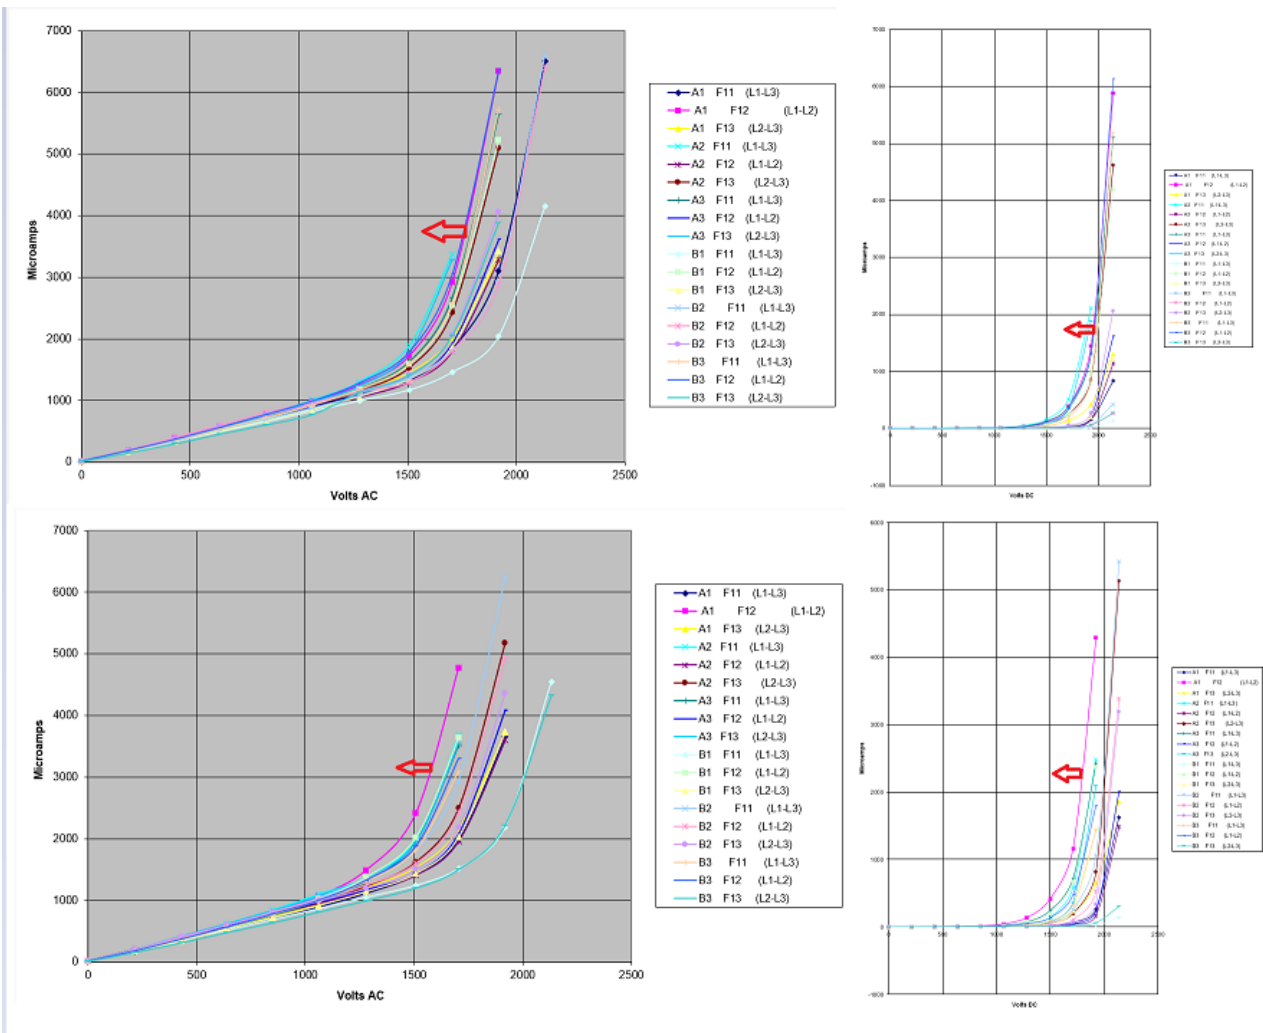
Measured AC/DC characteristic drift(leakage current increase) in one year period (cycloconverter A1 phase, F12 varistor between phases L1 & L2). If not replaced in time, AC/DC characteristic can drift up to point of Varistor explosion.

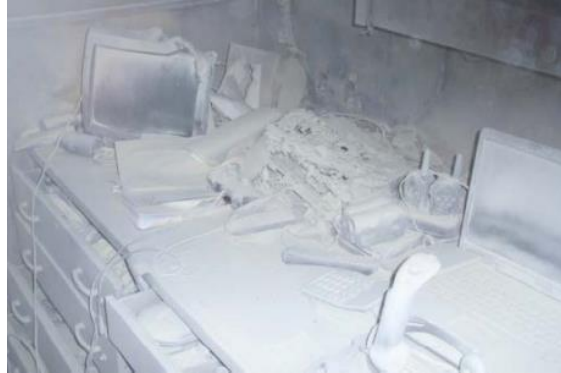
Varistors are widely used as Surge Protection Devices in electronics power supplies (automation, IT, entertainment, etc.) and in power strips. PQ/EMI issues can accelerate aging of varistors. Increased rate of power supplies failures indicating network PQ/EMI problems. Power strips with SPD protecting one conductor only should not be used onboard ([Microsoft Word - 03-13b.docx \(uscg.mil\)](#)). From experience, power strips should be without SPD due to varistor drifting phenomena. Increase in varistor (SPD) residual current (heating) can be checked with thermographic survey. Power cords are usually hidden and their overheating can not be seen until they melt power strip or cause fire.

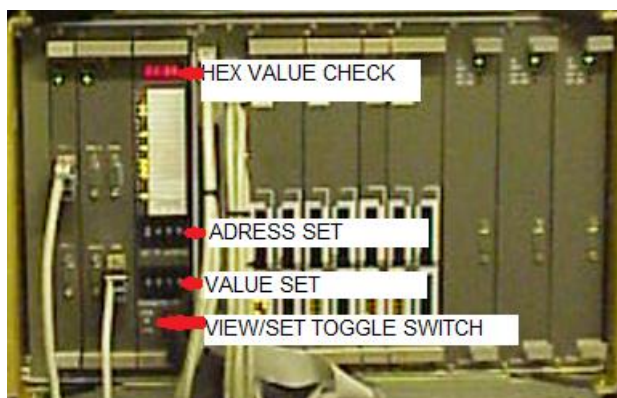
ABB cycloconverter PSR CPU failure happened in one of most remote part of the world. By cooling affected CPU card EPROMS drive started, but went in fault when EPROM heated up. From 2 spare cards, only one was not working, spare card assembler code was checked on drive (service card SD A338) using original code received from ABB.
