Optical technologies on modern ships

Mladen Radovanović
Boštjan Batagelj
5. 2. 2021

Challenges of optical technologies on a passenger ship

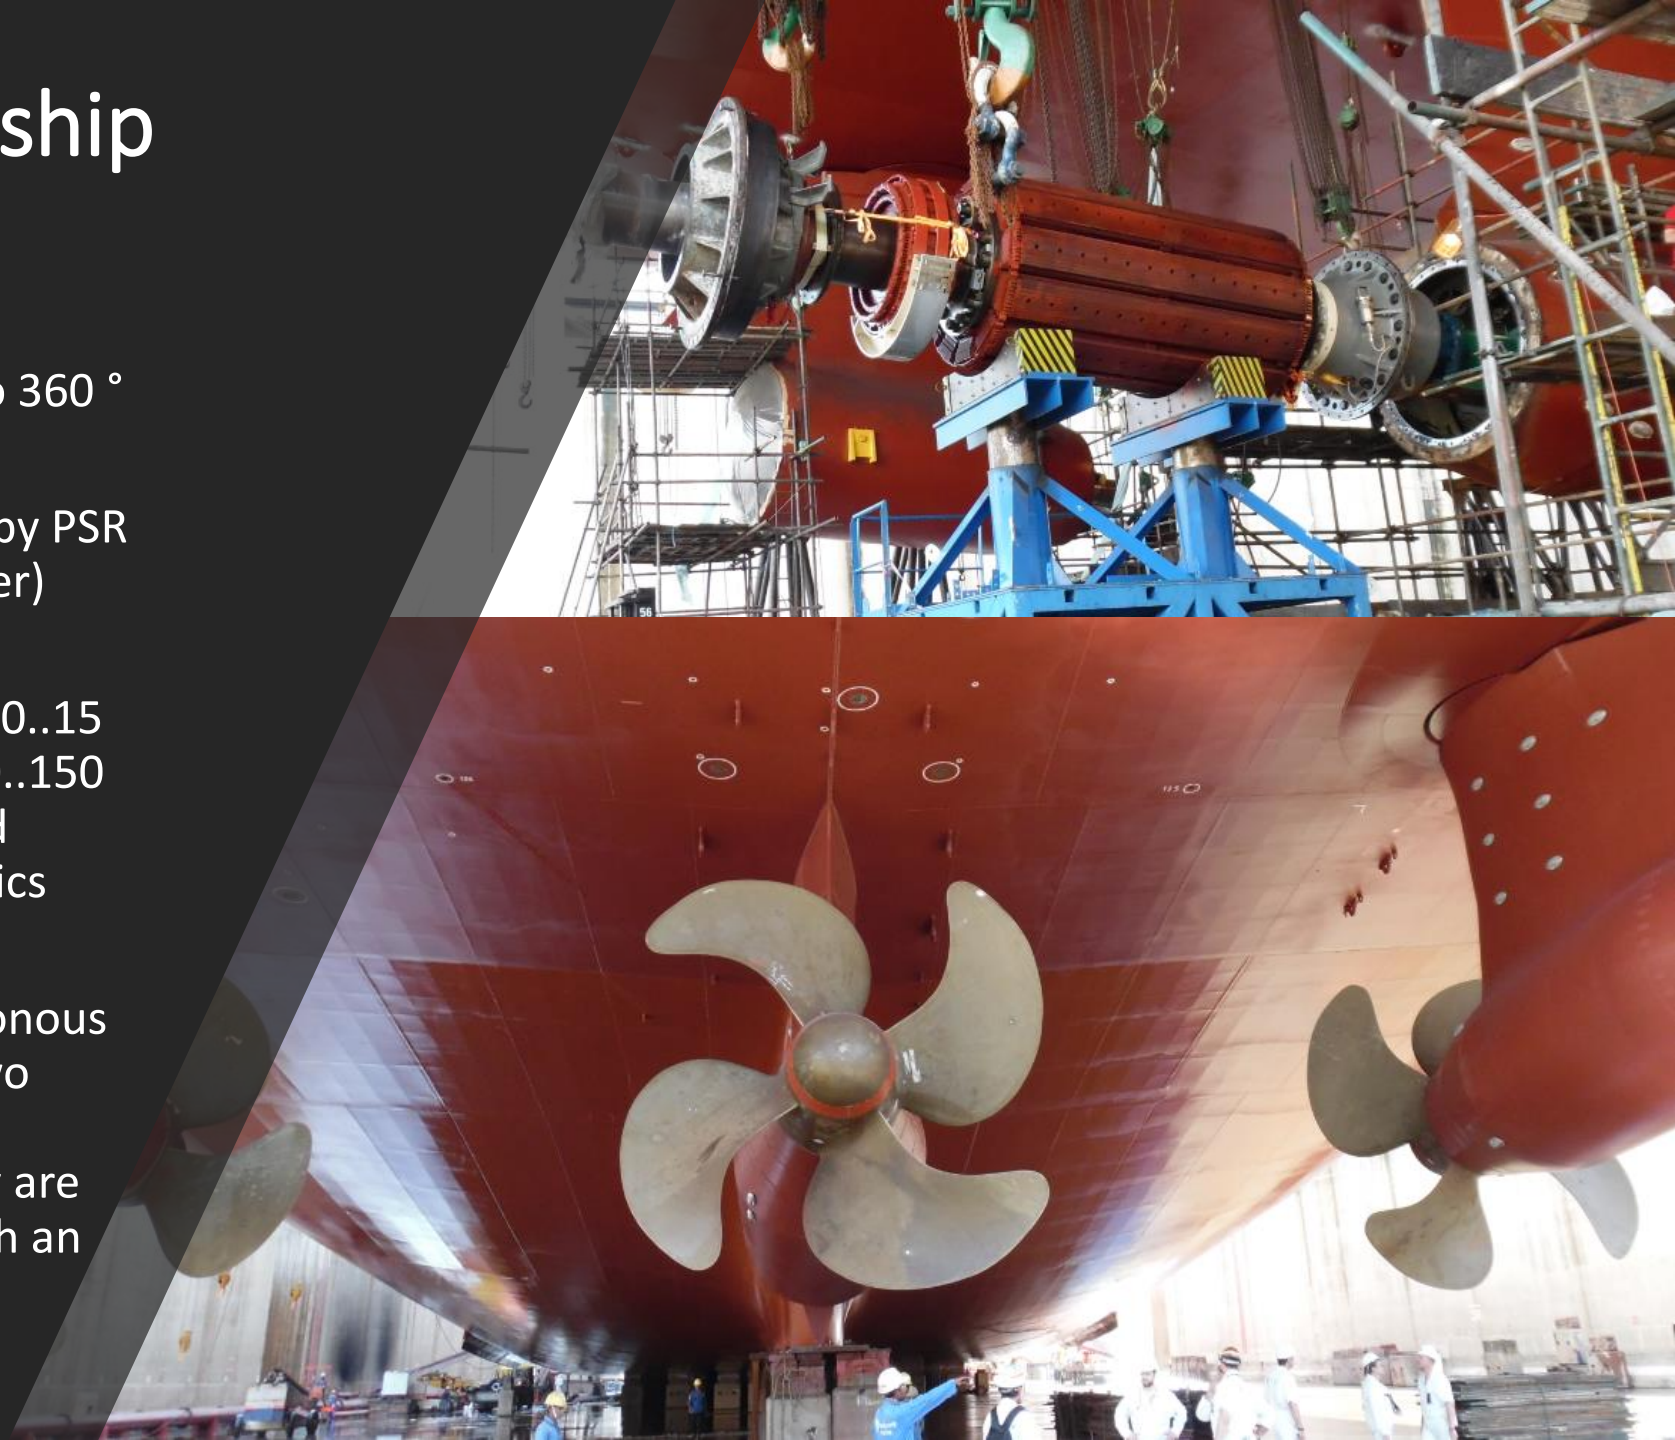
- three 15 MW marine drives, two 360 ° and one fixed (center)
- Synchronous motors are driven by PSR (Programmierbar Schnell Rechner) ABB cycloconverter
- operates in the range 0..1570 V, 0..15 Hz, with a working range of -150..150 rpm, rated current 2x2626 A and water cooling of power electronics with an efficiency of 96.7%.
- Each drive has a six-pole synchronous motor with double armature, two three-phase windings are mechanically offset by 60 °, they are driven by two electric drives with an electric offset of 120 °

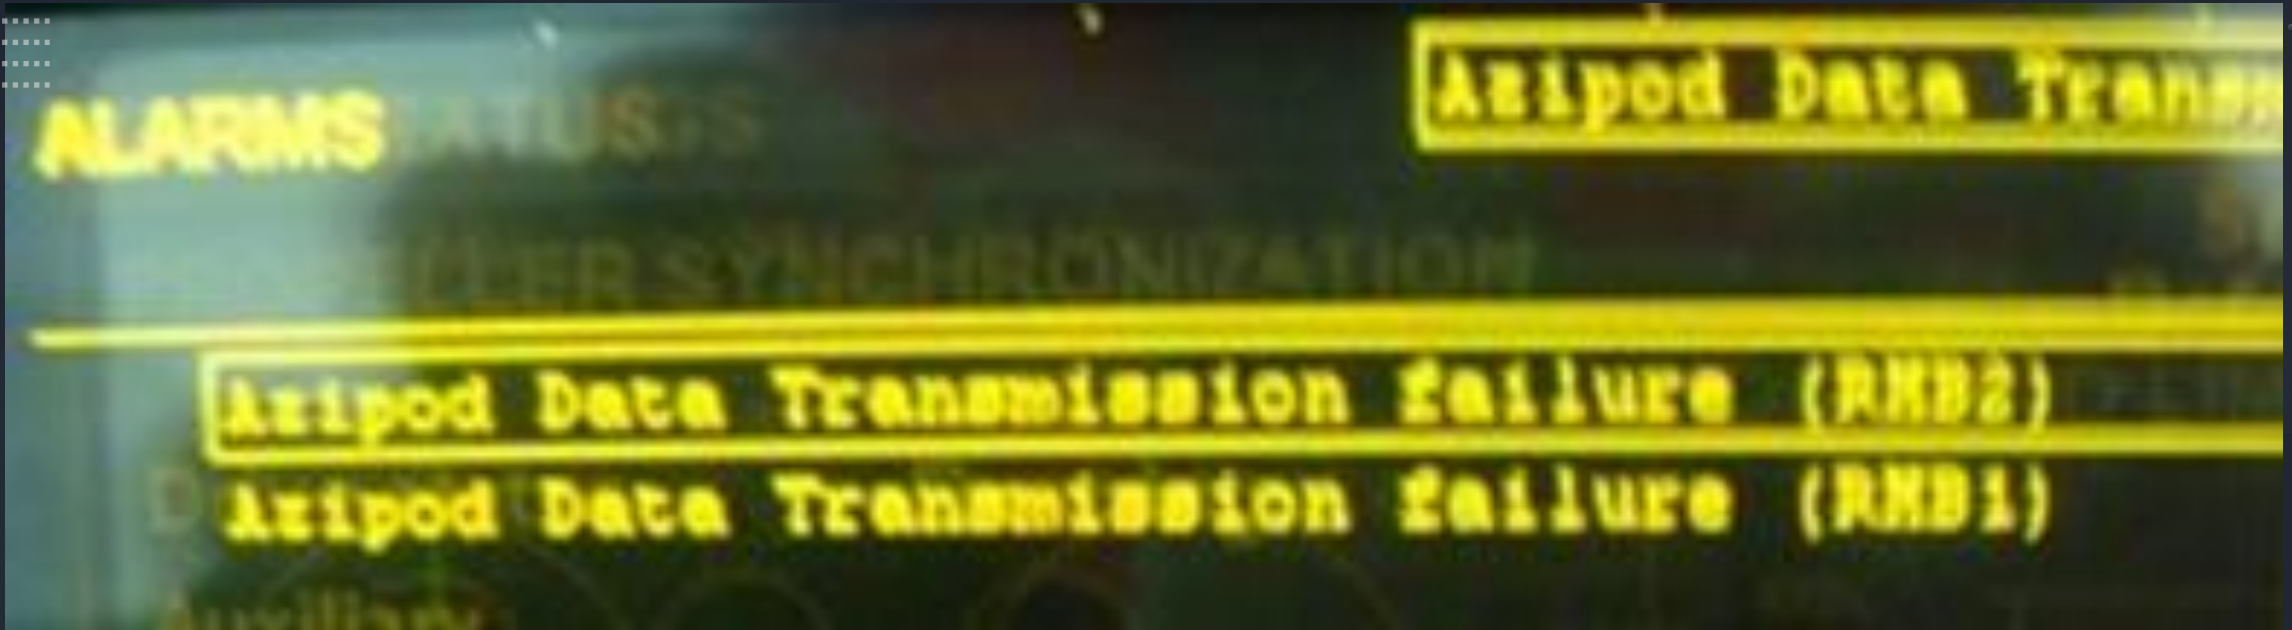
Rotor position feedback

- The position feedback, angle λ of the rotor of the propeller electric motor in the cycloconverter is used to transform the coordinate systems from a 3-axis R, S, T stator to a two-axis rotor d, q vector system. The resolution of the 13 bit Gray code encoder TR HE-65-S LWL is 0.044° . The Gray code is used because changes between two angles are present on only one bit, thus reducing the possibility of an error in the transmission of the angle.

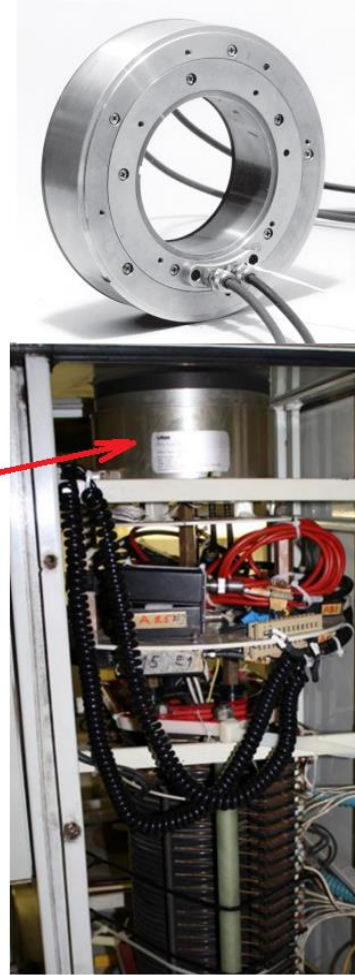
Optical path from position encoder to decoder in cycloconverter electric drive controller

- If the rotor angle information is not available, the drive is switched off. This most often happens due to a fault in the transmission path from the rotor encoder to the Beckhoff M110 decoder in the cycloconverter. Switching off the drive is an extremely dangerous navigation event, especially if the ship is in maneuver (navigation in rivers, canals, entry or exit into port, narrow navigation corridors with a lot of traffic).

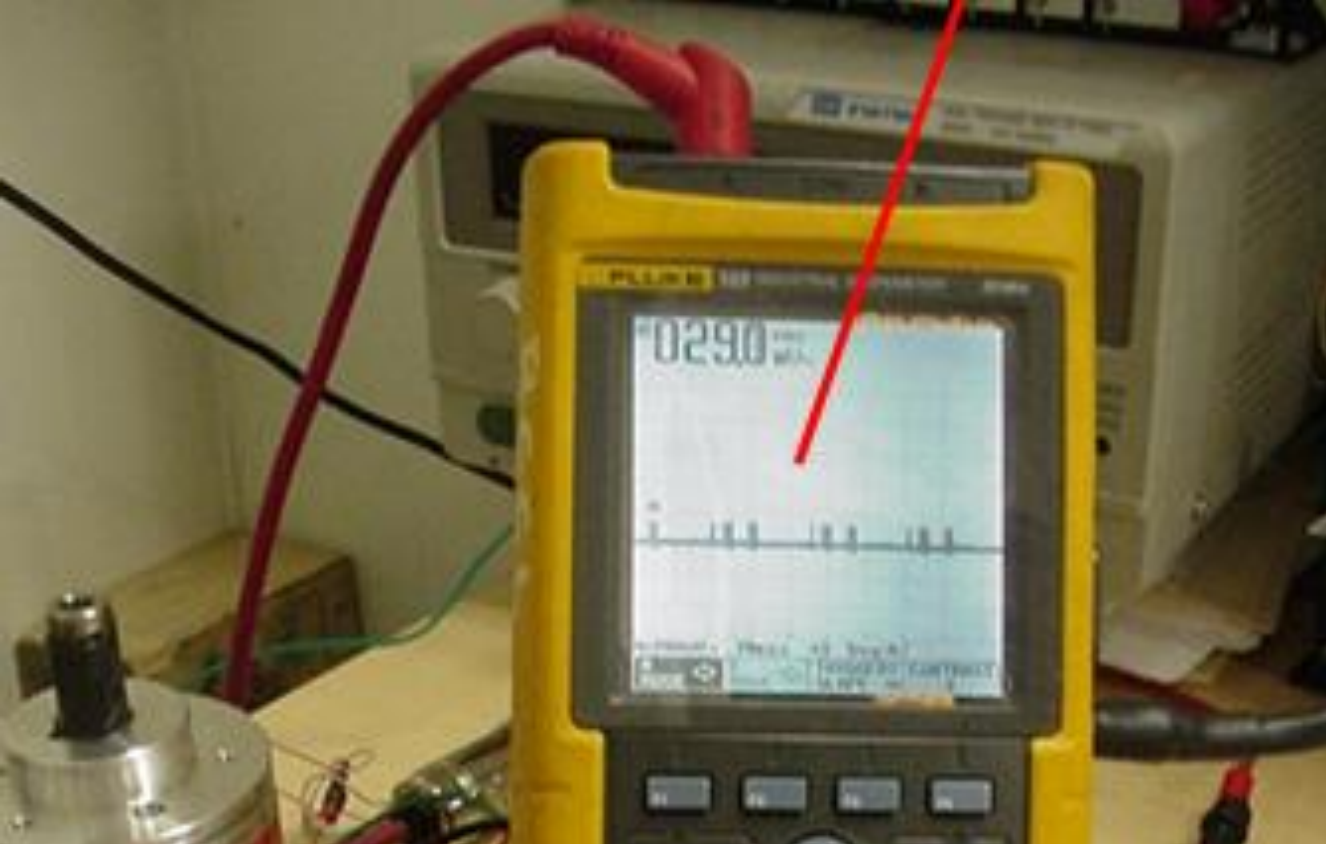
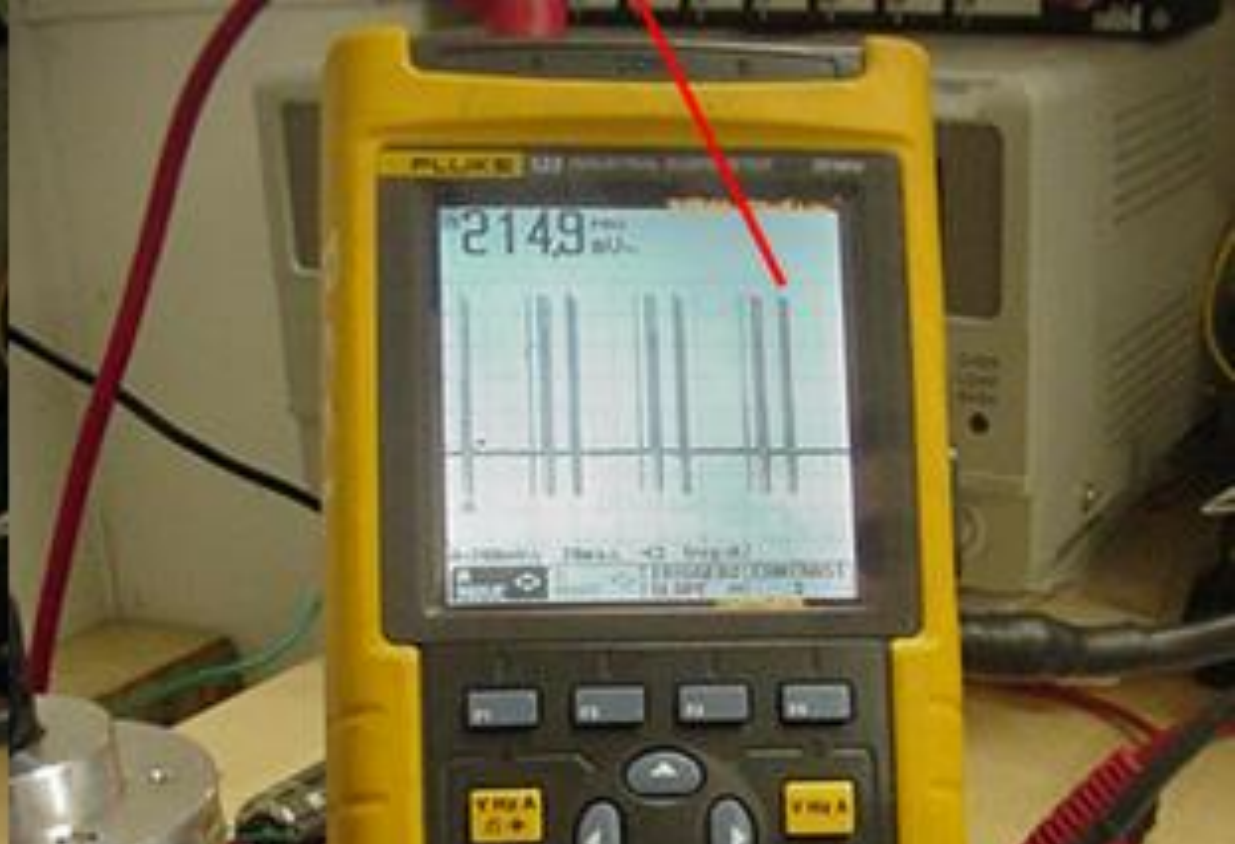
Poškodovan drseči prsten za 24Vdc napajanje tranceiverja A25,A26,A15,A16-->začasno uporabljen prašičji rep kabel (Ang. pigtail)

- Encoder optical signal modulation was lost due to a fault on the sliding rings (24 Vdc power loss for transceivers A25, A26, A16, A16 used to change the wavelength of the optical signal due to adjustment to the optical rotating ring). To determine the cause of the fault, the transceiver was processed and on / off modulation was observed on the oscilloscope.

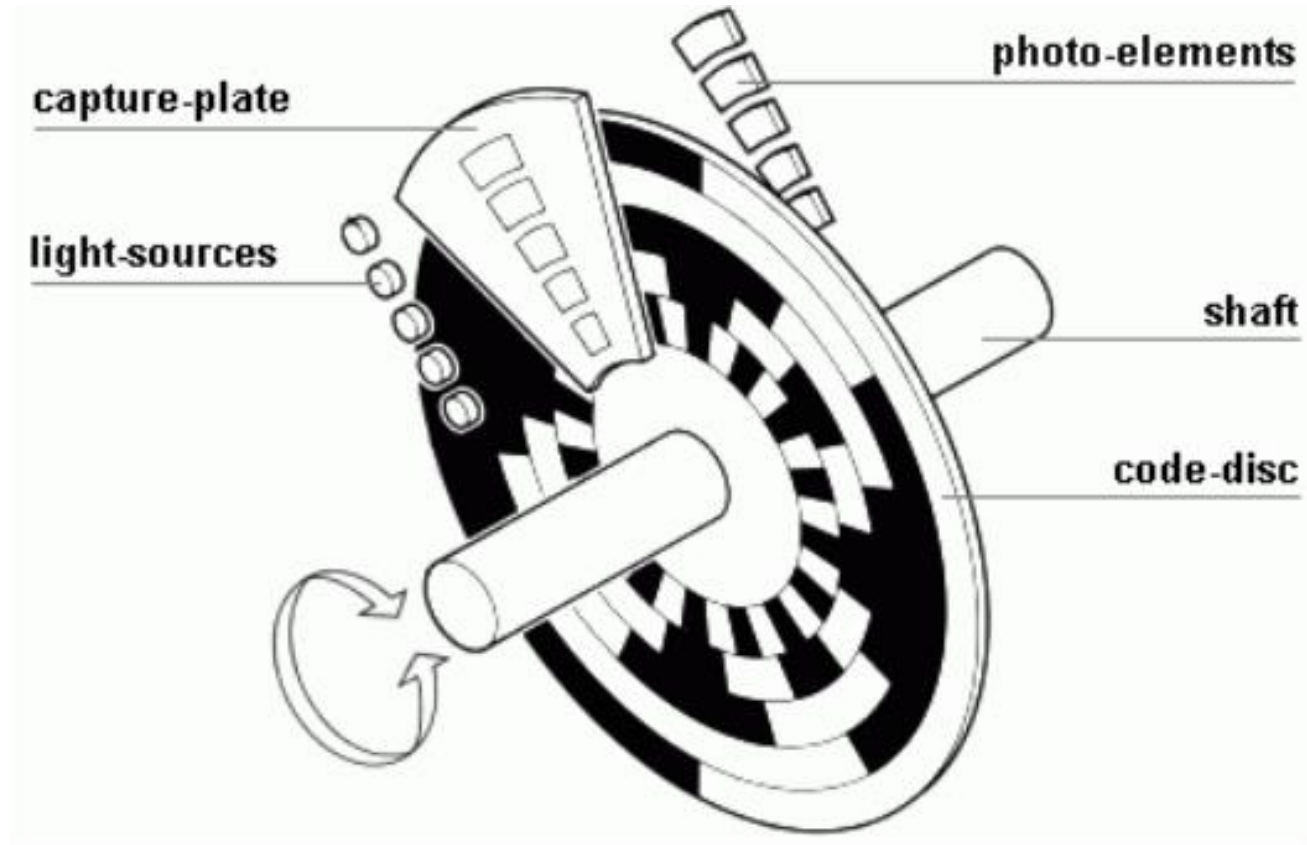
Angle encoder building

- The error in measuring the angle can also be due to the aging of the bearings or the vibration of the encoder, which is made as an optical disk with 13 Gray code rings.

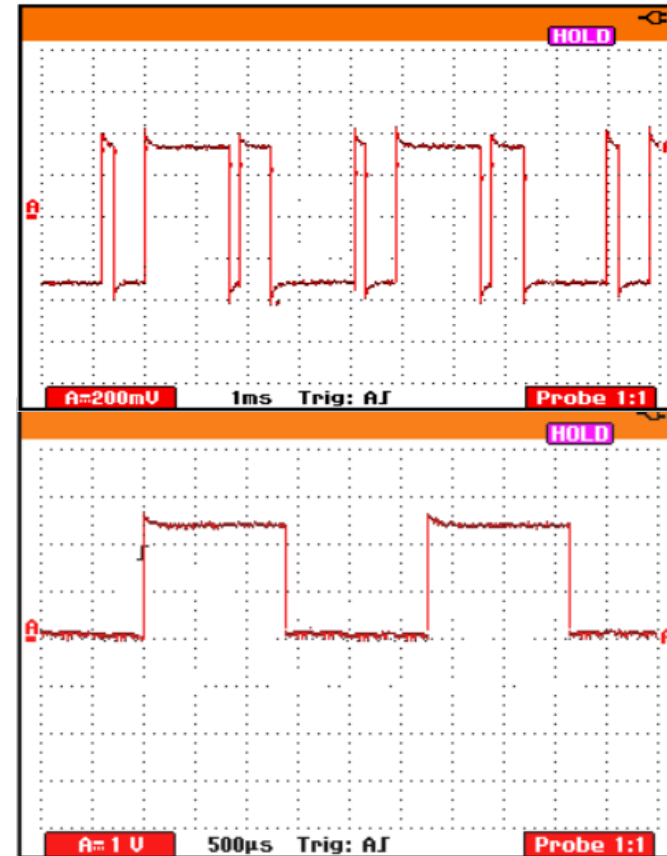
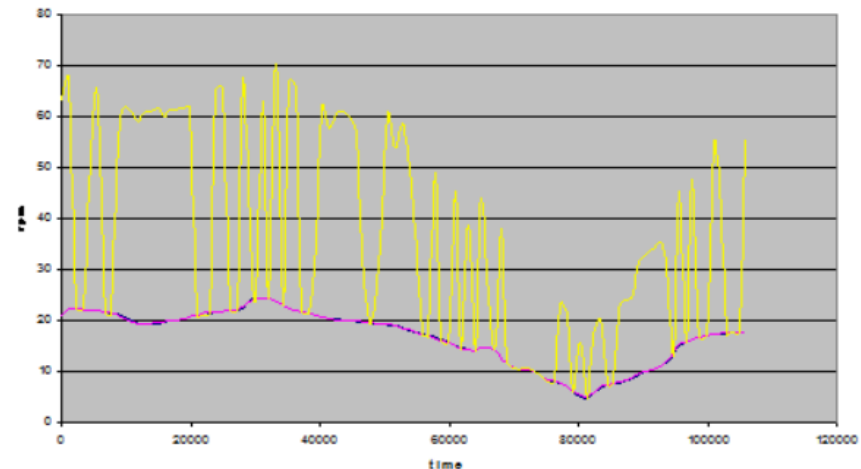
- The period of the fifth bit is equal to the rotation period of the synchronous motor rotor and is therefore used as feedback on the motor speed, together with the fifth bit of the second encoder and the voltage period of the cycloconverter (the drive has two windings mechanically offset by 60 degrees electric drive with 120 degree electric delay) Napaka na kodirniku pri petem (5) bitu in kodirnik brez napake

- An error in the fifth (5) bit results in an incorrect measurement of the rotation period and, in the worst case, the drive is switched off.
- Timely fault detection is part of the maintenance work and in this case, the incorrect encoder is replaced. After replacing the encoder, the initial calibration is performed: excitation of the synchronous motor with DC surges is done, until the rotor stops, the actual angle between mechanical and electrical zero measured by the new encoder is recorded in the controller of the cycloconverter.

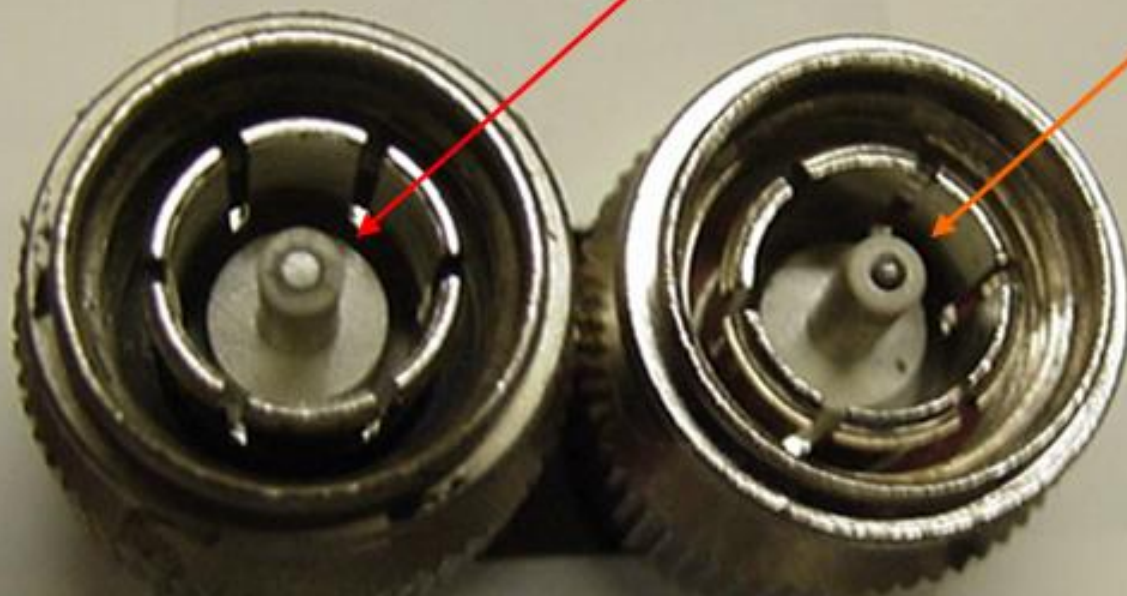
Harting F-TNC connectors

FO jedro 1000 μm

FO jedro 400 μm

AC01287-15 (FO core 1000um) AC01287-12 (FO core 400um)

Incorrect optical fiber placed with 400 μm core instead of 1000 μm

increased contact attenuation due to longitudinal displacement on fiber optic connectors spaced apart by vibration (1 mm longitudinal displacement approximately 3 dB attenuation)

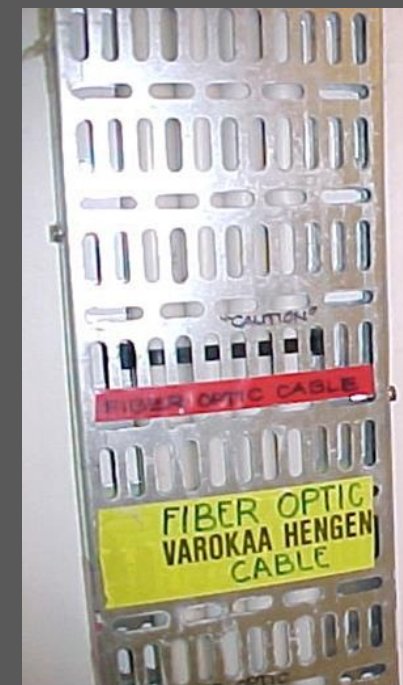
The optical fibers were placed through the same space. In the event of fire or mechanical damage (ship collision), all three drives may fail at the same time. In the picture below, the optical cables from the STB (right if looking towards the bow of the ship) and the fixipod go through the technical room of the PS drive (left if looking towards the bow of the ship).

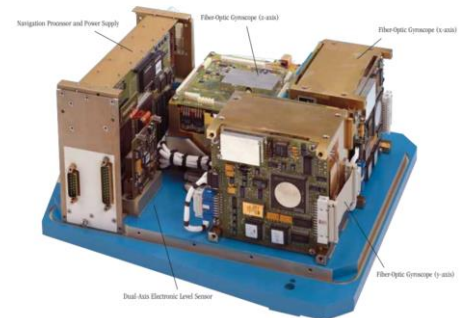
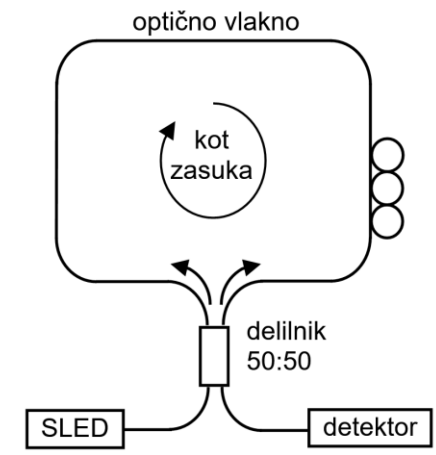
- Sperry Navigat 2100 fiber optics gyroscope
- Older mechanical gyroscopes, consist of a rotating wheel in gyroscopic fluid and exploit the principle of maintaining the rotational speed, began years ago to be replaced with modern 3 axes optical gyroscopes
- They works on Sagnac phenomen measuring the change in phase of a light in the fiber coil traveling in oposite directions due superposition of Earth rotational speed.
- Optical gyroscopes do not require annual servicing as mechanical (gyroscopic fluid replacement and calibration)

$N \rightarrow$ NUMBER OF FIBER LOOPS
 $R \rightarrow$ FIBER LOOP RADIUS
 $D = 2R, L = 2\pi RN$

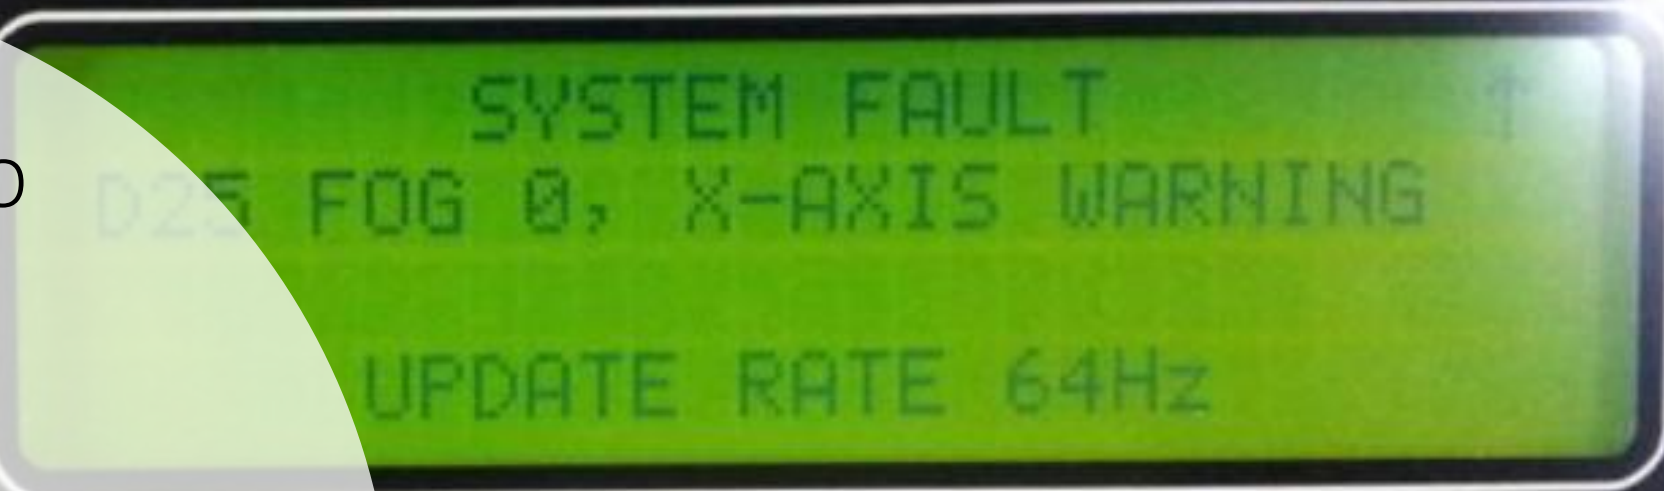
Error of one axis of the FO gyroscope

- The light source used is SLD (SuperLuminescent Diode). Due to the aging of the diodes (power degradation and spectral change), the average time to error (MTBF) is 30,000 h or 3.4 years. One of the main reasons for the lower service life is the extremely high injection current density in the SLD; to obtain the same power, 4-5 mW, which 14 kA / cm² current is required for SLD and only 3-4 kA / cm² for LD.

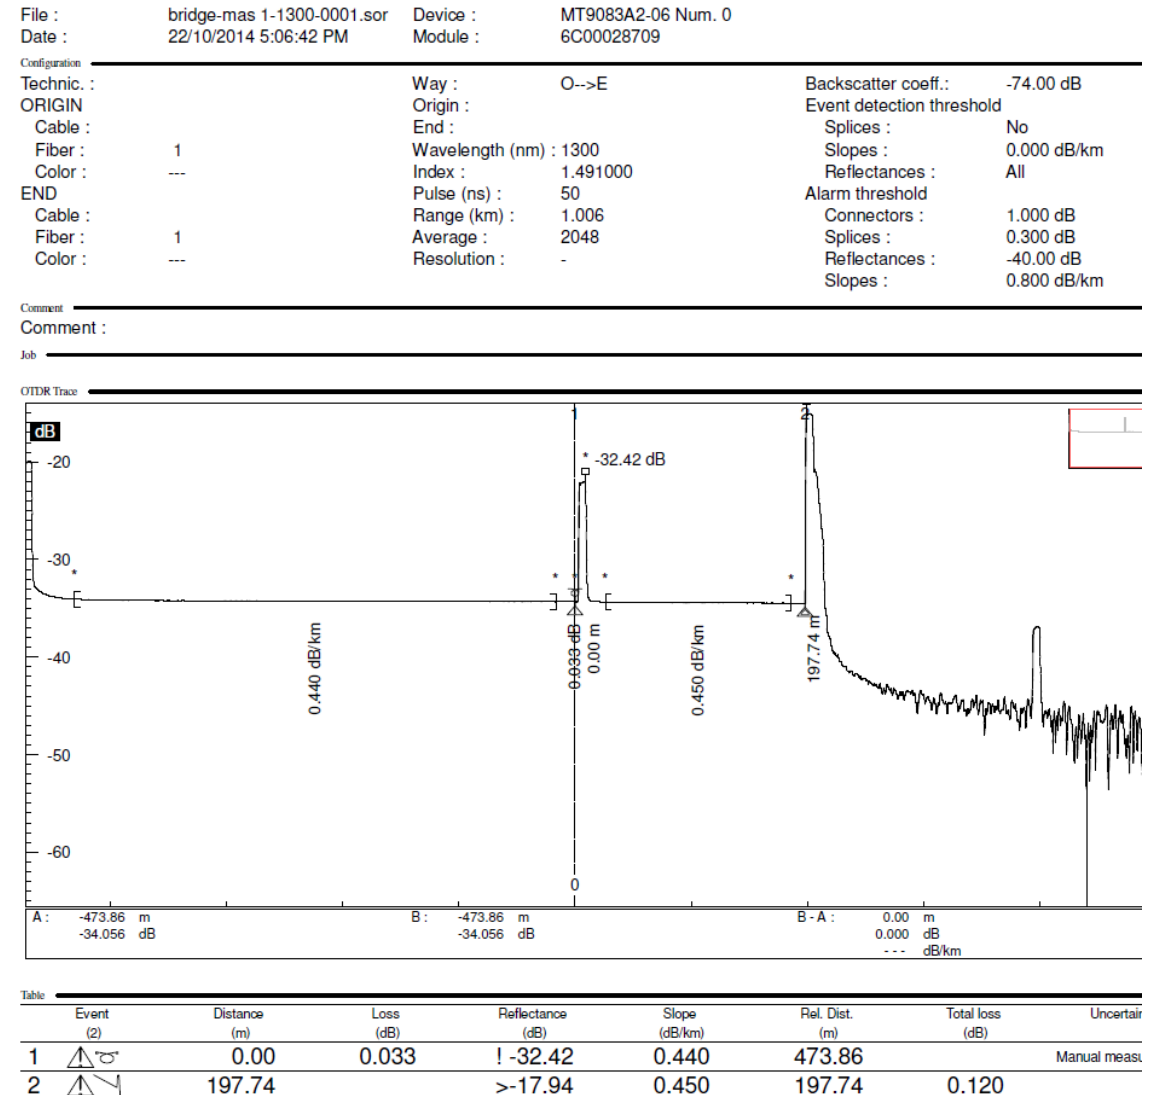
OTDR measurements (angl. Optical Time Domain Reflectometer)

- The critical phase of the project after laying the cables and mounting connectors the are OTDR measurements (attenuation, dispersion, numerical aperture, location of possible damage or fiber breakage)
- OTDR measurements were performed with the Anritsu MT9083A2-06 instrument at two wavelengths of 850 n in 1300 nm.
- The measured values are used as a reference in further measurements at system start-up and future maintenance work (SPF monitoring of optical system core: monitoring PIN diodes aging, fiber damadges, FO connector issues, etc)

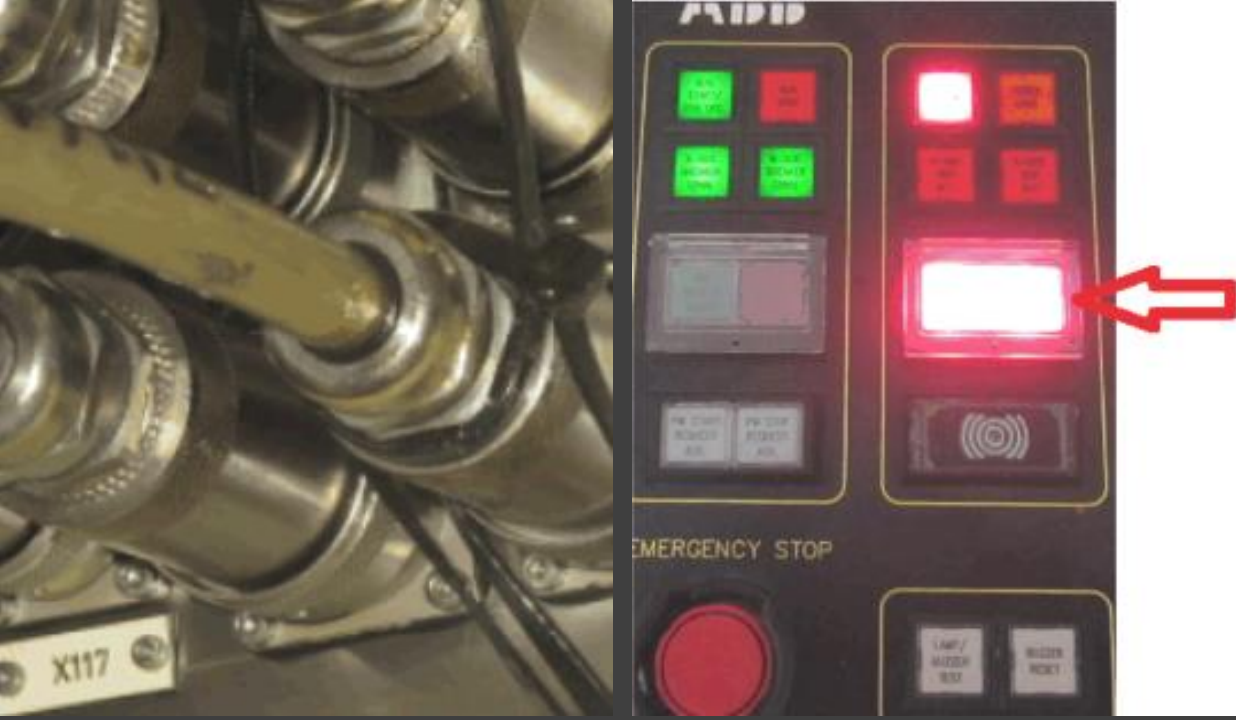
- ▶ MOXA switches made in the period from April 2013 to October 2016 can randomly turn off the inputs / outputs of the switches, suddenly restart or even "hang" without any response. The cause is internal overload/EM interference on the 60 nm SDRAM, which leads to an error in the read / write cycles of the central processing unit.
- ▶ The author experienced failures of the ship's command of the propulsion, unreliable operation and failures of security systems (Main Fire Zones fire doors closing, accidental activation of the fire extinguishing system (Sprinkler system), integrated navigation system ECDIS failures, blackout in the PMS system (Power Management System).
- ▶ On one ship, it was replaced more than 130 industrial switches in various systems.

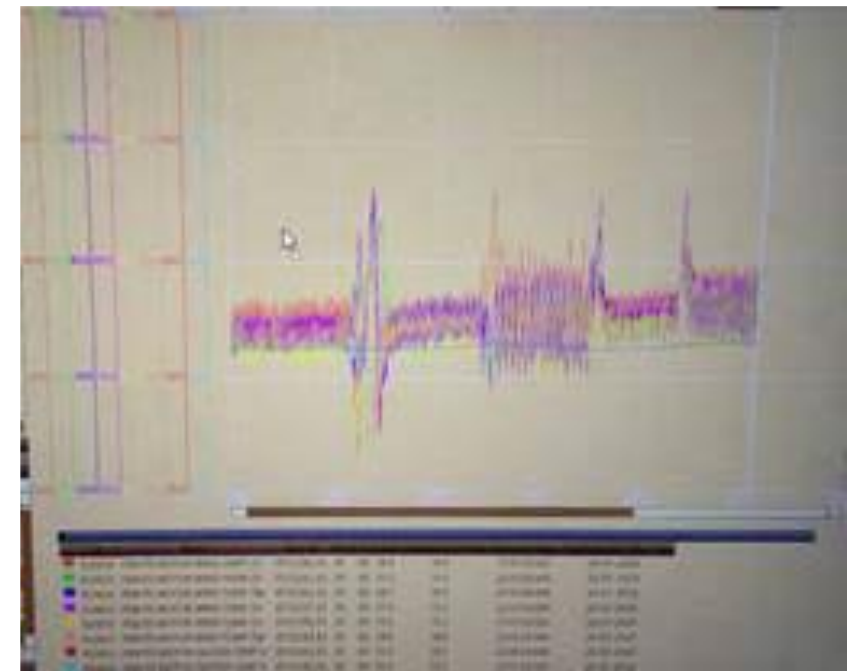
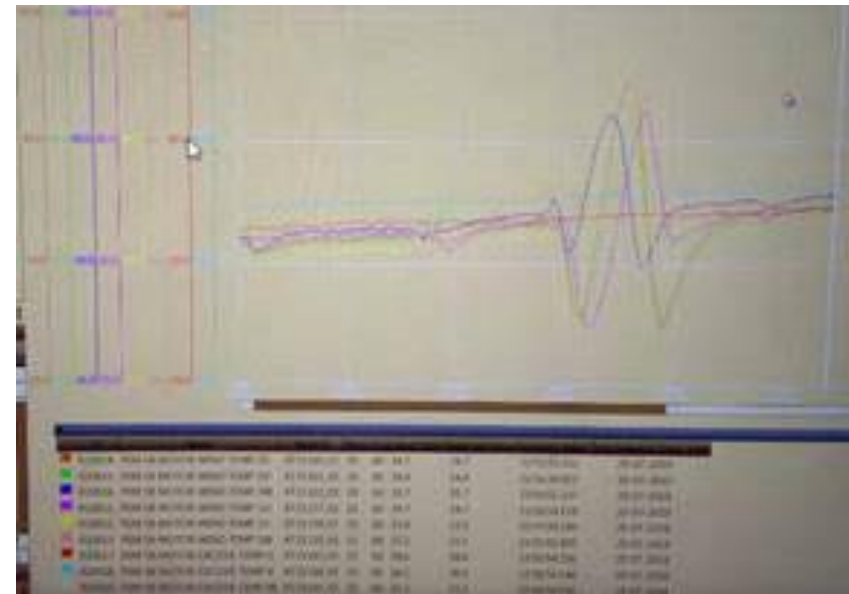
Temperature fluctuations on 8.5 MW marine drive

- On the 8.5MW marine drive, a fluctuation in the temperature of the PEM electric motor (Propulsion Electrical Motor) $\pm 30^\circ\text{C}$ with a period of several minutes was detected due to a system error and recalibration of the WAGO 750-461 module, which occurs with speed change of the electric motor and the effect of EM interference in PT100 three-wire measurements.
- The figure shows the motor temperature fluctuation and the temperature fluctuation with the implemented 60s digital filter in the drive controller.

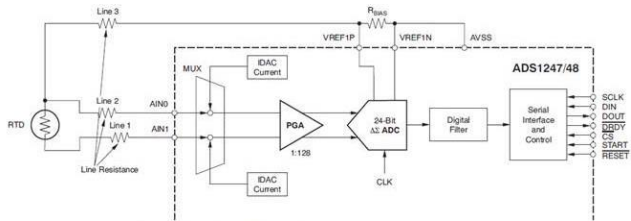
Implementation of three wire measurements with TI ADS1247

NOTE: R_{exc} must be as close to the ADC as possible.

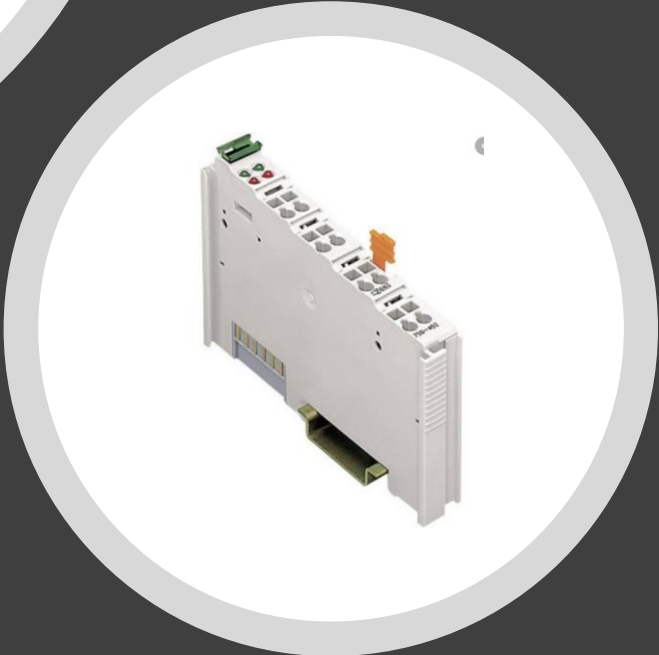
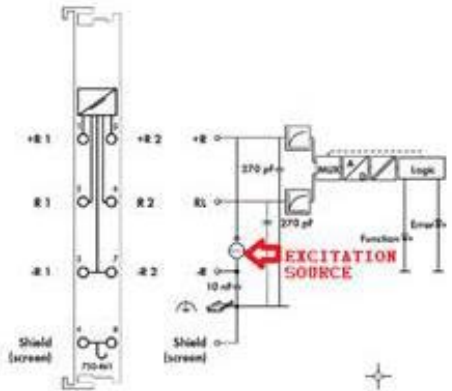
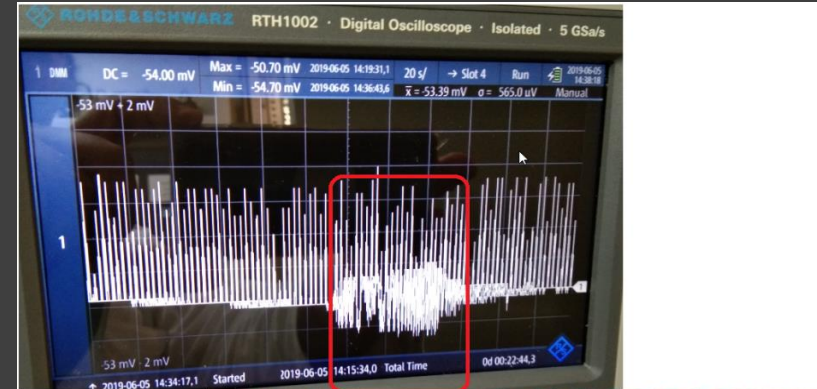
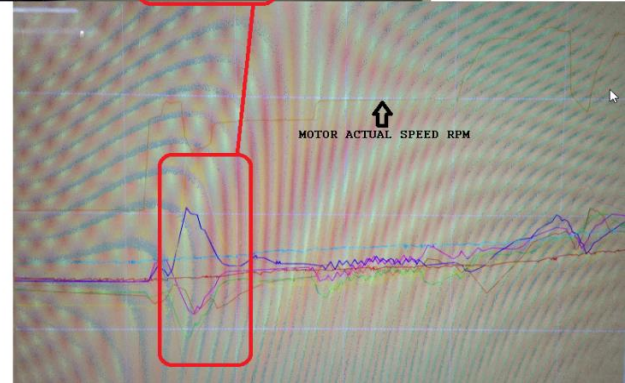
modul WAGO 750-461

By measuring the voltage drop at terminals 2/3, it is shown that the module controller is recalibrated when the rotor speed changes and the effect of EM interference. Unfortunately, the recalibration cannot be turned off,

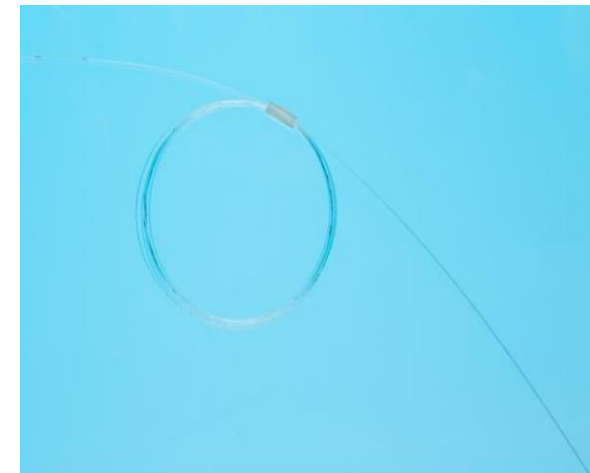
FBG Sensor in Acrylate Coated Fibre

- The Bragg fiber diffraction mesh can be used as a built-in optical filter to block certain wavelengths or as a reflector specific to the wavelength. By changing the periodic properties of the core due to temperature or shrinkage / tension, an optical fiber with a Bragg structure can be used as a sensor to measure temperature, e.g. winding of a synchronous machine or strain on the hull of a ship
- Compared to PT100 Class AA sensors, defined in the range -50 ... + 250 ° C (resistor with wire winding), 0... + 150 ° C (thin film resistor)] FBG fibers have twice the temperature resolution ± 0.05 ° C and a wider measuring range -270 ÷ 300 ° C

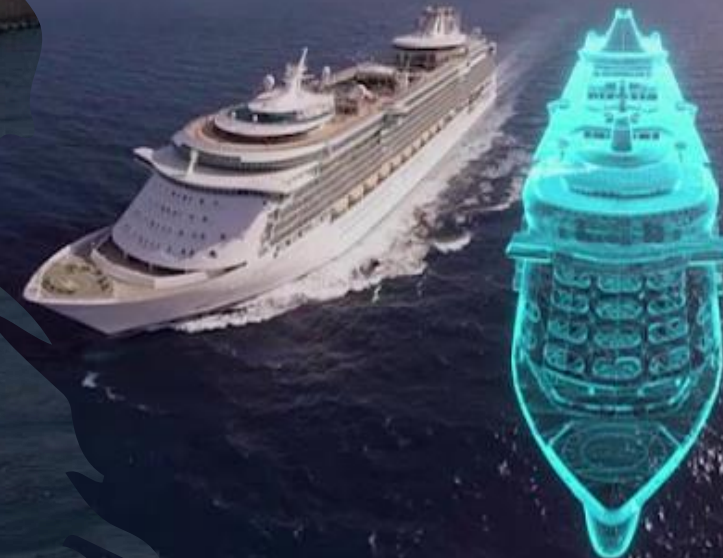
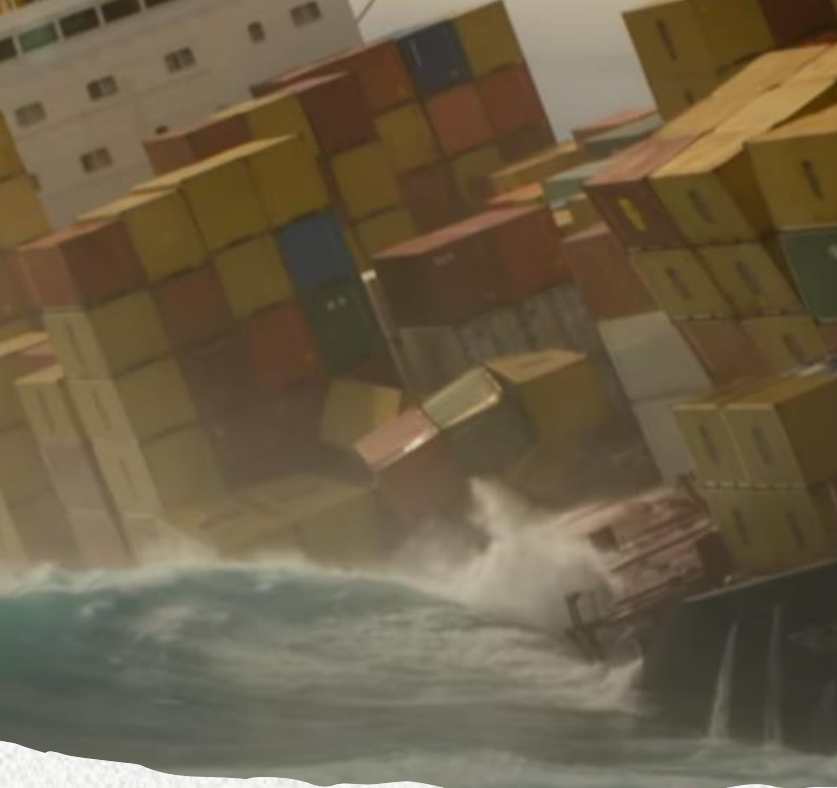
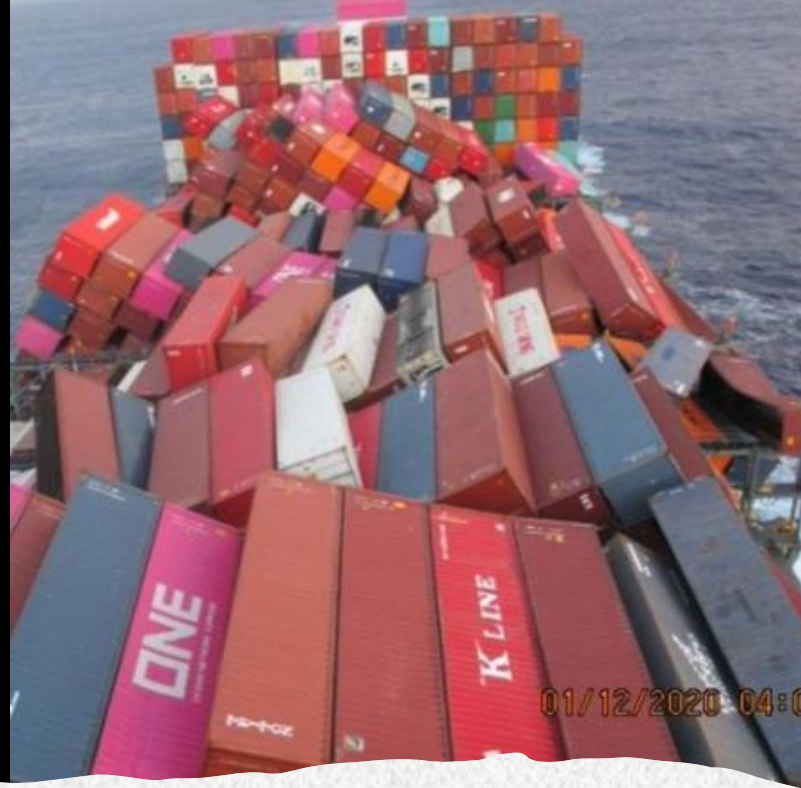
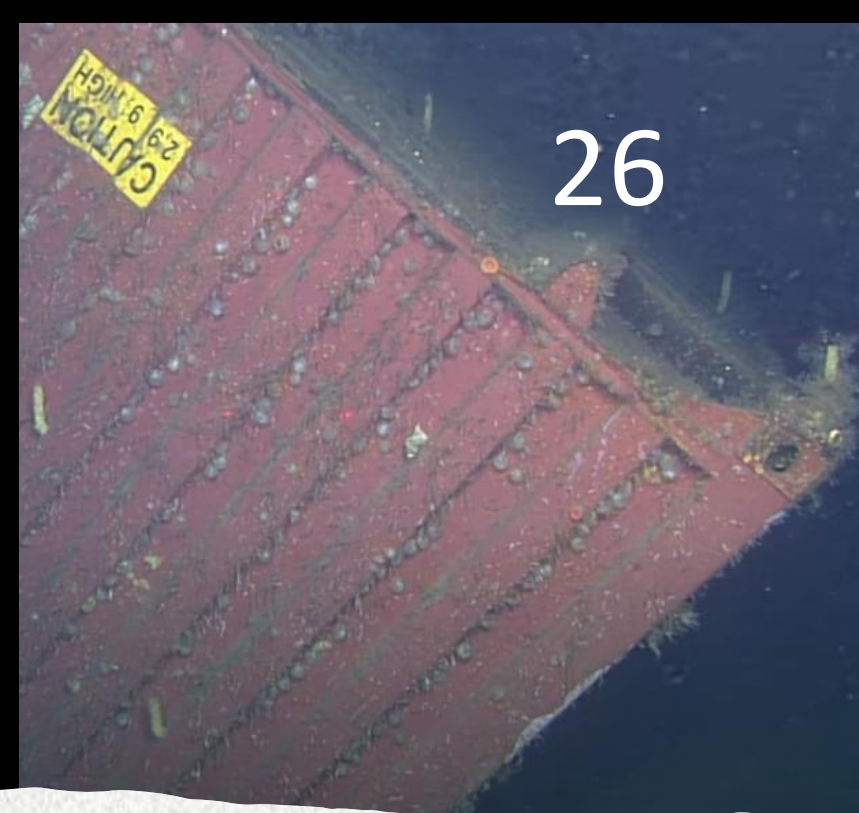
FBG hull strain measurements and digital twin concept

- Consequences of ship hull overstress can be hull damages or hull breakdown
- Increased hull stress due to climate change and increase of Significant Wave Height
- The concept of a digital ship twin is used to monitor the state of a ship in real time
- The inputs to the twin model are state of the PMS, 3D state of the sea around the ship (use of low cost mmWave radars or FFB fibers) and in front of vessel (processing X band radar backscatter reflections from the sea surface), the structural response or stress of the ship's hull using FBG sensors, vessel stability, weather conditions, current speed, wind direction, ship dynamics and other vessel parameters
- Based on above inputs vessel Twin model can be offset in time and used for avoiding dangers such as extreme left-right oscillations (parametric roll), real time optimisation of PMS and fuel savings

- an optical fiber with distributed FBS sensors around the ship can also be used to measure the thrust force of the sea buoyancy on the optical fiber, which depends on the wave height, the information is used as input to the digital twin model.
- frequent occurrence of parametric ship oscillations is safety and environmental concern, in the last event in December 2020, 1900 containers were lost, of which 40 with dangerous cargo
- Monitoring the hull strain in real time contributes to safer navigation, along with the captured information on the state of the sea, the data can be used for timely measures in case of high hull stresses (inspections and repairs) and improvements in ship design.
